Memorandum

Date: *August 15, 2014*

Subject: *Oversight Summary Report
CPG Oversight of RM 10.9 Removal Action
Lower Passaic River Restoration Project*

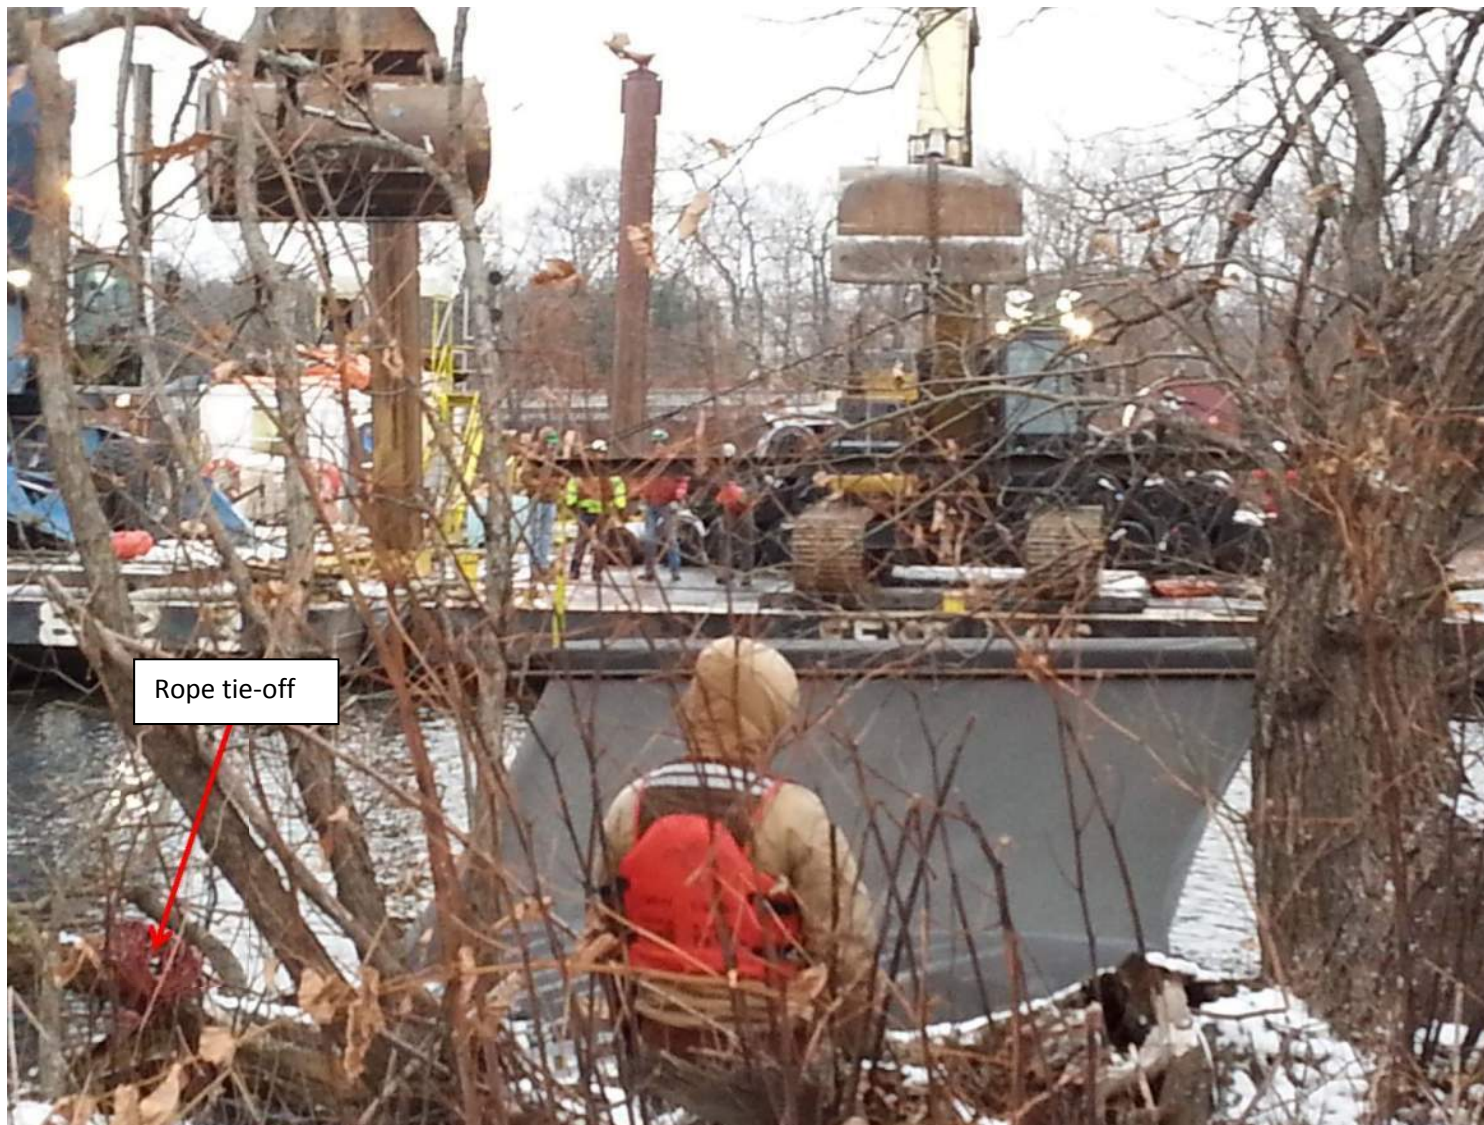
December 14, 2013 0750: GLDD personnel tying off the panel to onshore tree branches/stumps. The fabric is being picked up by the wind, within moments of this photo; the CAT operator lowered the roll to just above the water surface, mitigating the effects of the wind on the fabric.

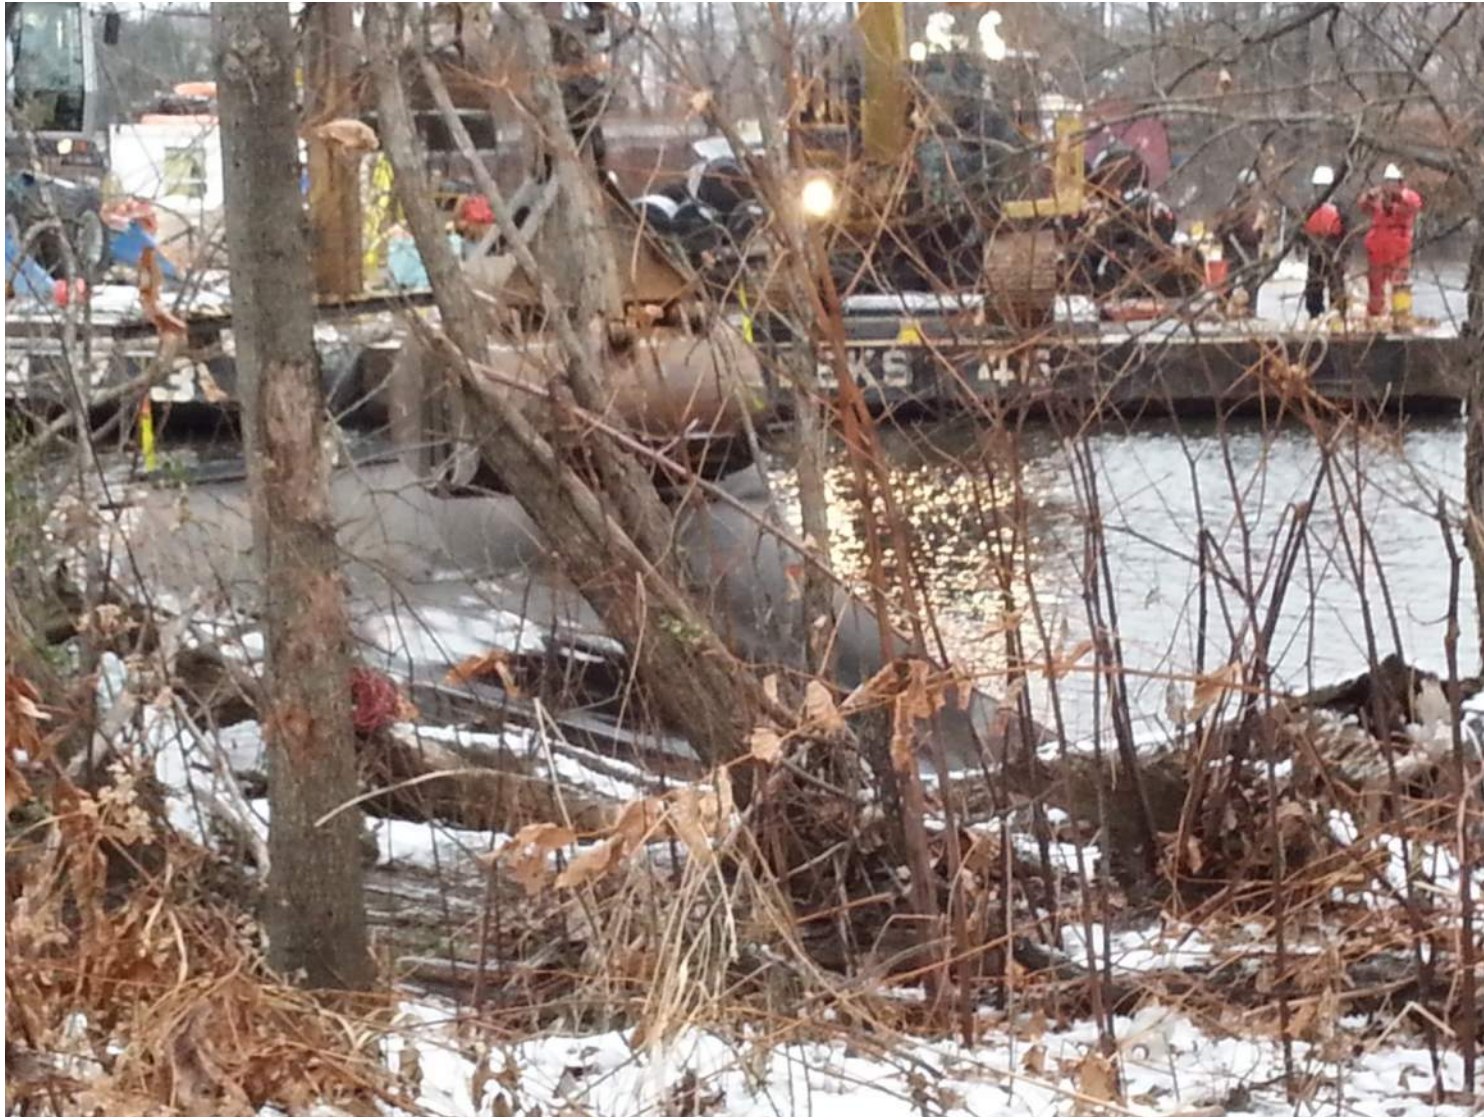
December 14, 2013 0755: GLDD installing first batch of Type A armor stone. Please note the fabric roll is tied off and the CAT operator has positioned it just above the water surface. The wind effects are well-mitigated.

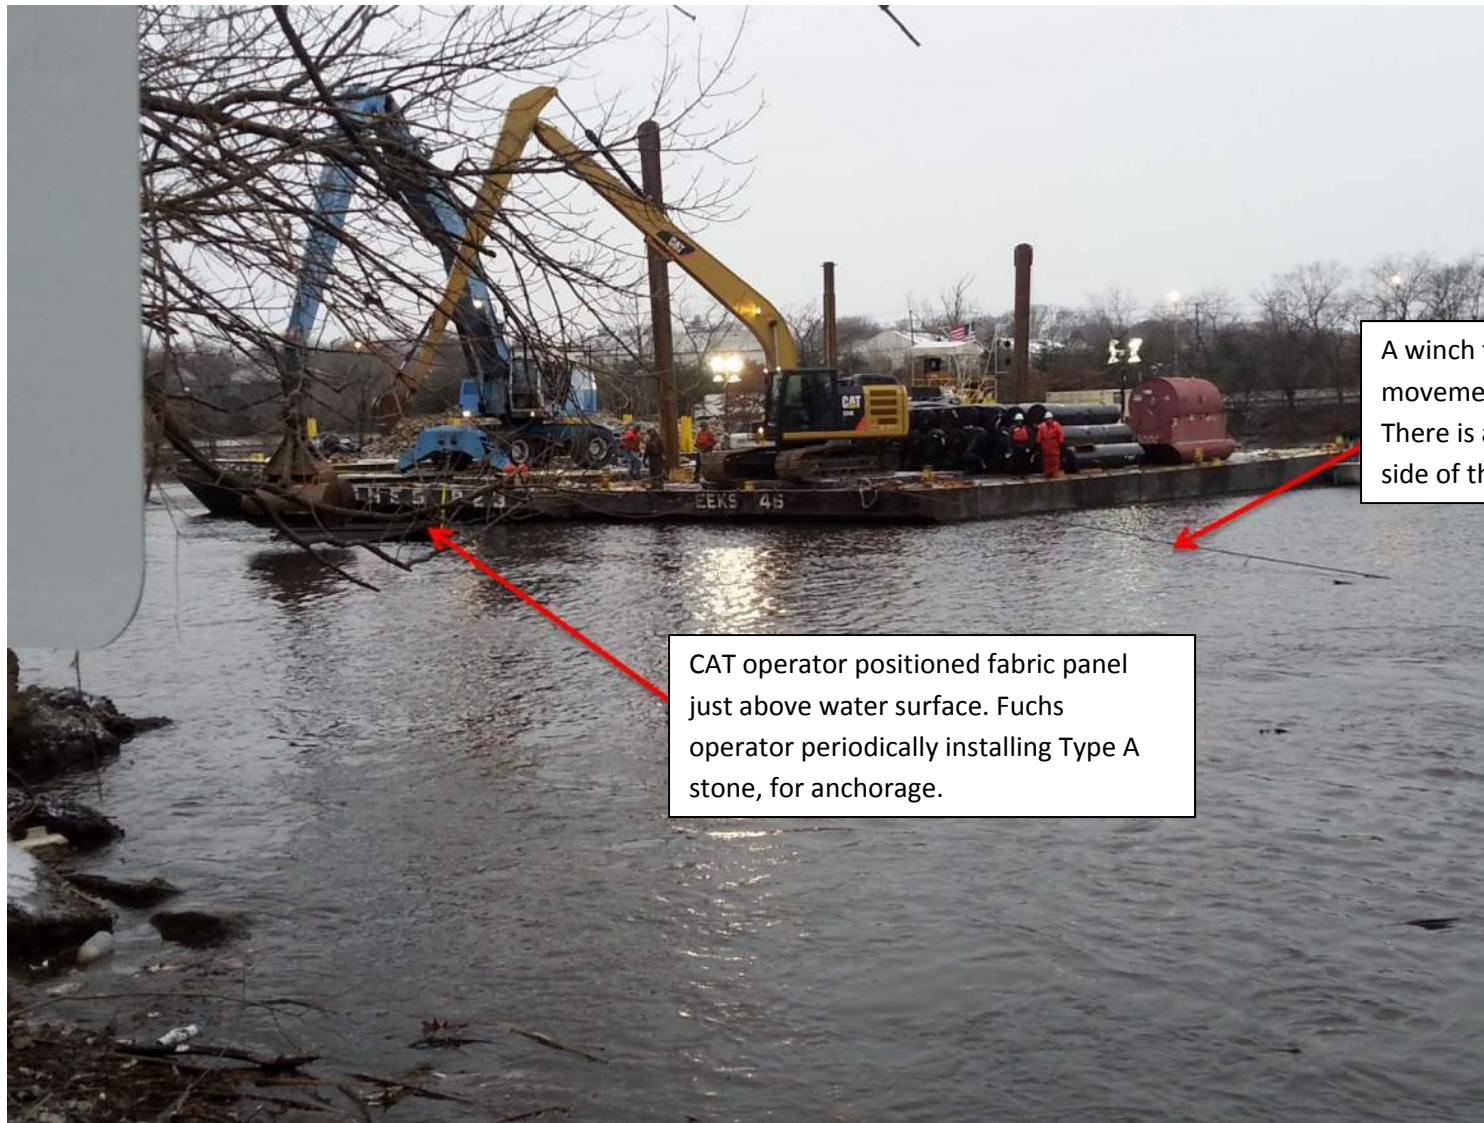
A winch to provide controlled movement from shoreline to channel. There is a second winch on the south side of the Fuchs excavator, off screen.

CAT operator positioned fabric panel just above water surface. Fuchs operator periodically installing Type A stone, for anchorage.

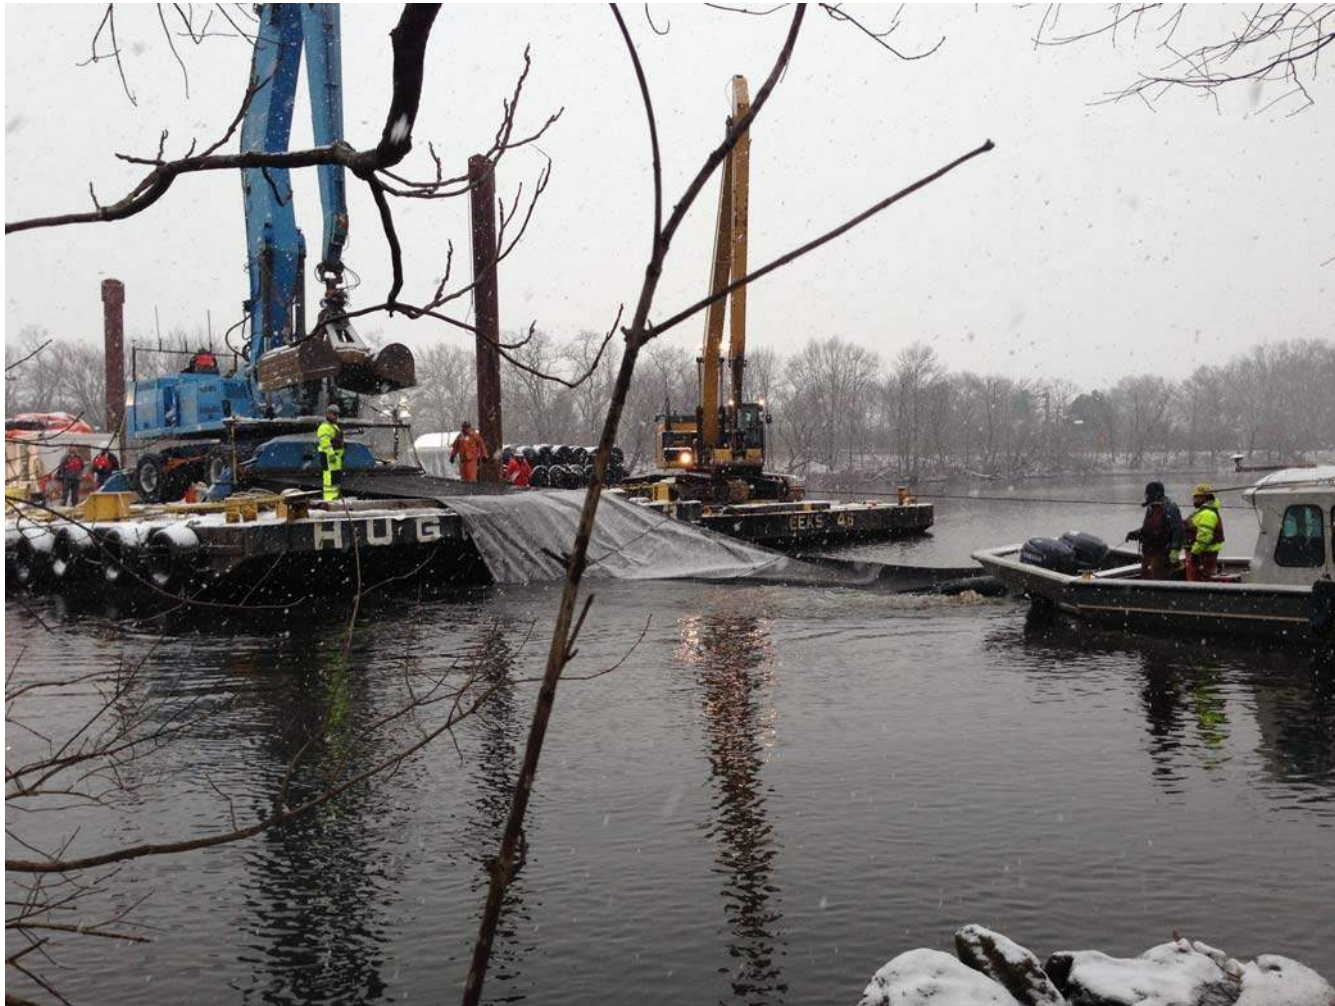
Geotextile Fabric with Rebar

GLDD installed rebar onto the geotextile fabric to help maintain its shape during installation. A piece is visible on the portion of fabric hanging off the side of the barge.

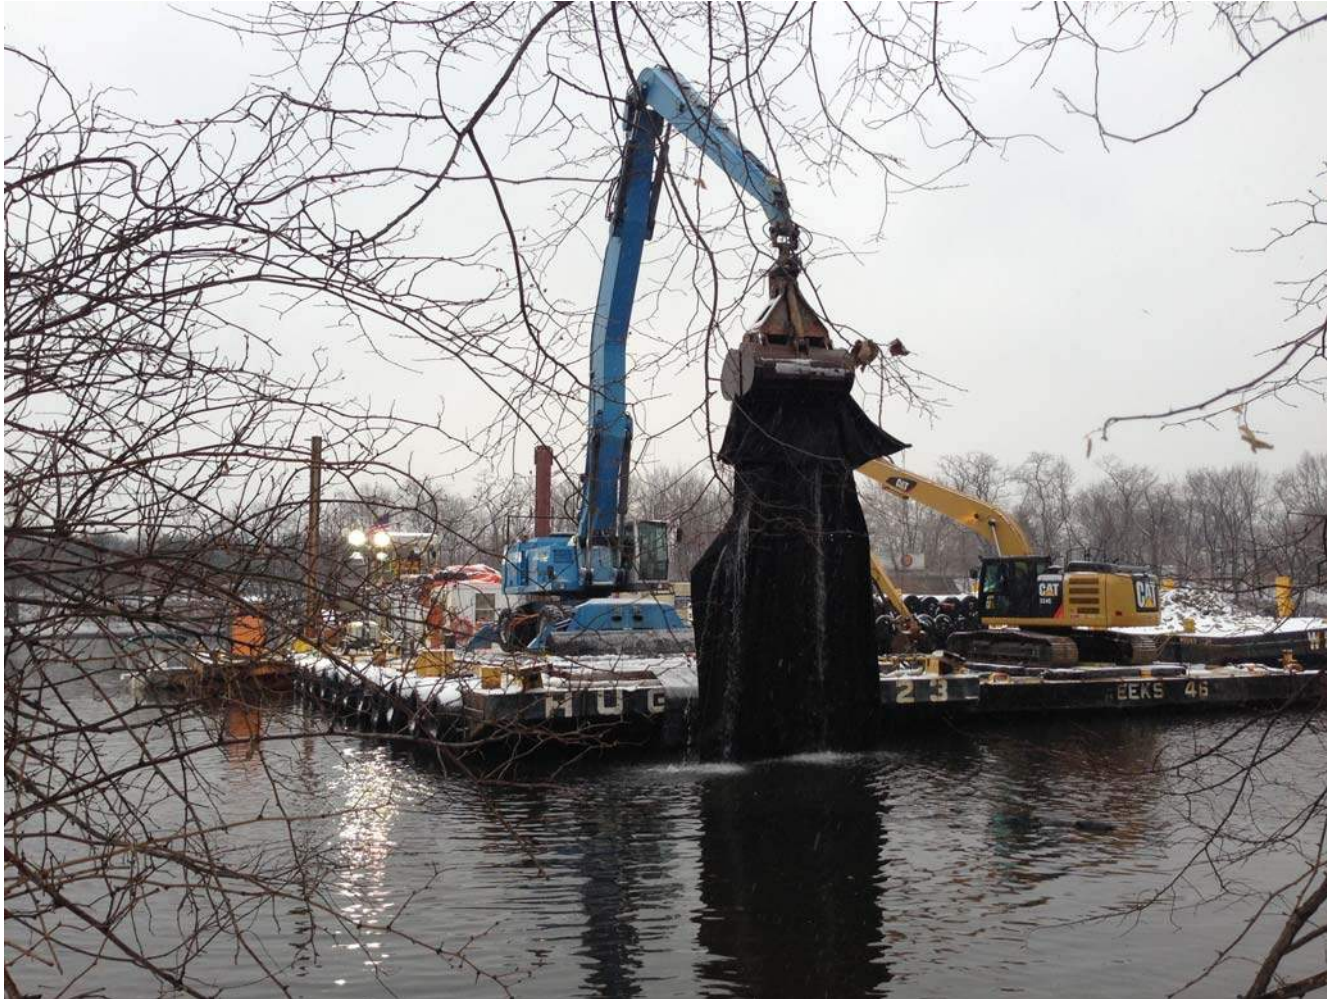
Abandonment of Installation Attempt

As a high tide passed, GLDD abandoned this installation attempt due to difficulties manipulating the fabric from the shoreline. They removed the fabric altogether, as shown above.

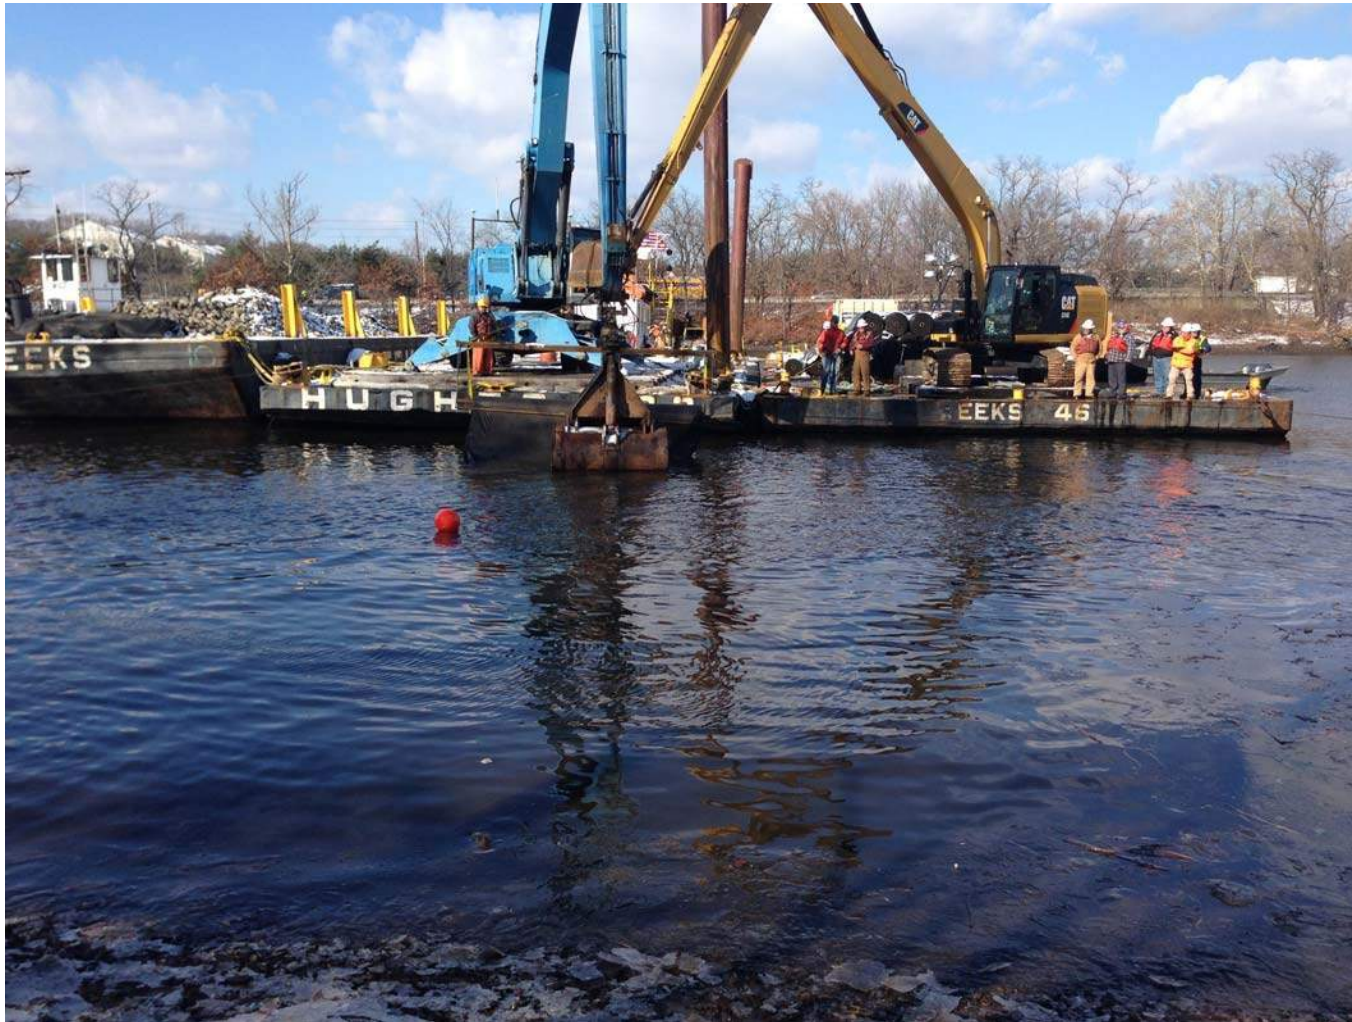
Installation Attempt – Geotextile/Geocomposite

GLDD attempted to install geotextile bound to a more rigid geocomposite grid. The attempt was unsuccessful because they were again unable to have the material lay flat during armor stone placement.

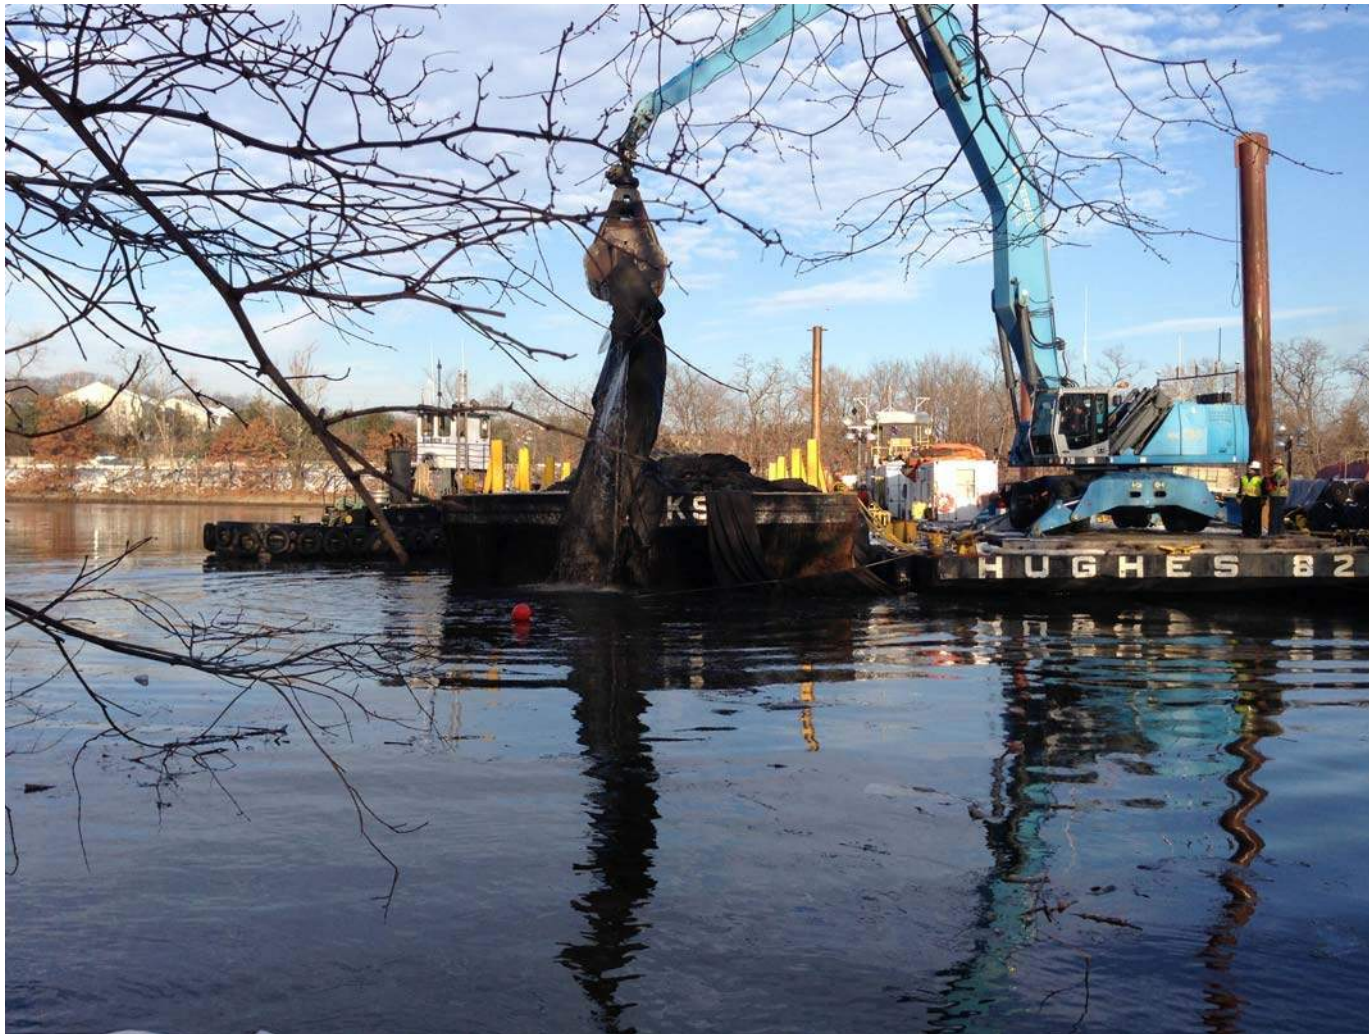
Geotextile Removal

GLDD removed the geotextile fabric that was placed during earlier unsuccessful attempts. The fabric was pulled out from beneath the armor stone, which was not removed. There will be no more in-river activity until Monday, December 30th.

The armor stone that was previously placed atop the geotextile fabric was not removed. It will need to be removed prior to the next attempt at geotextile placement. There was no clear evidence of damage to the active layer during the fabric removal, but only the non-submerged area could be judged.

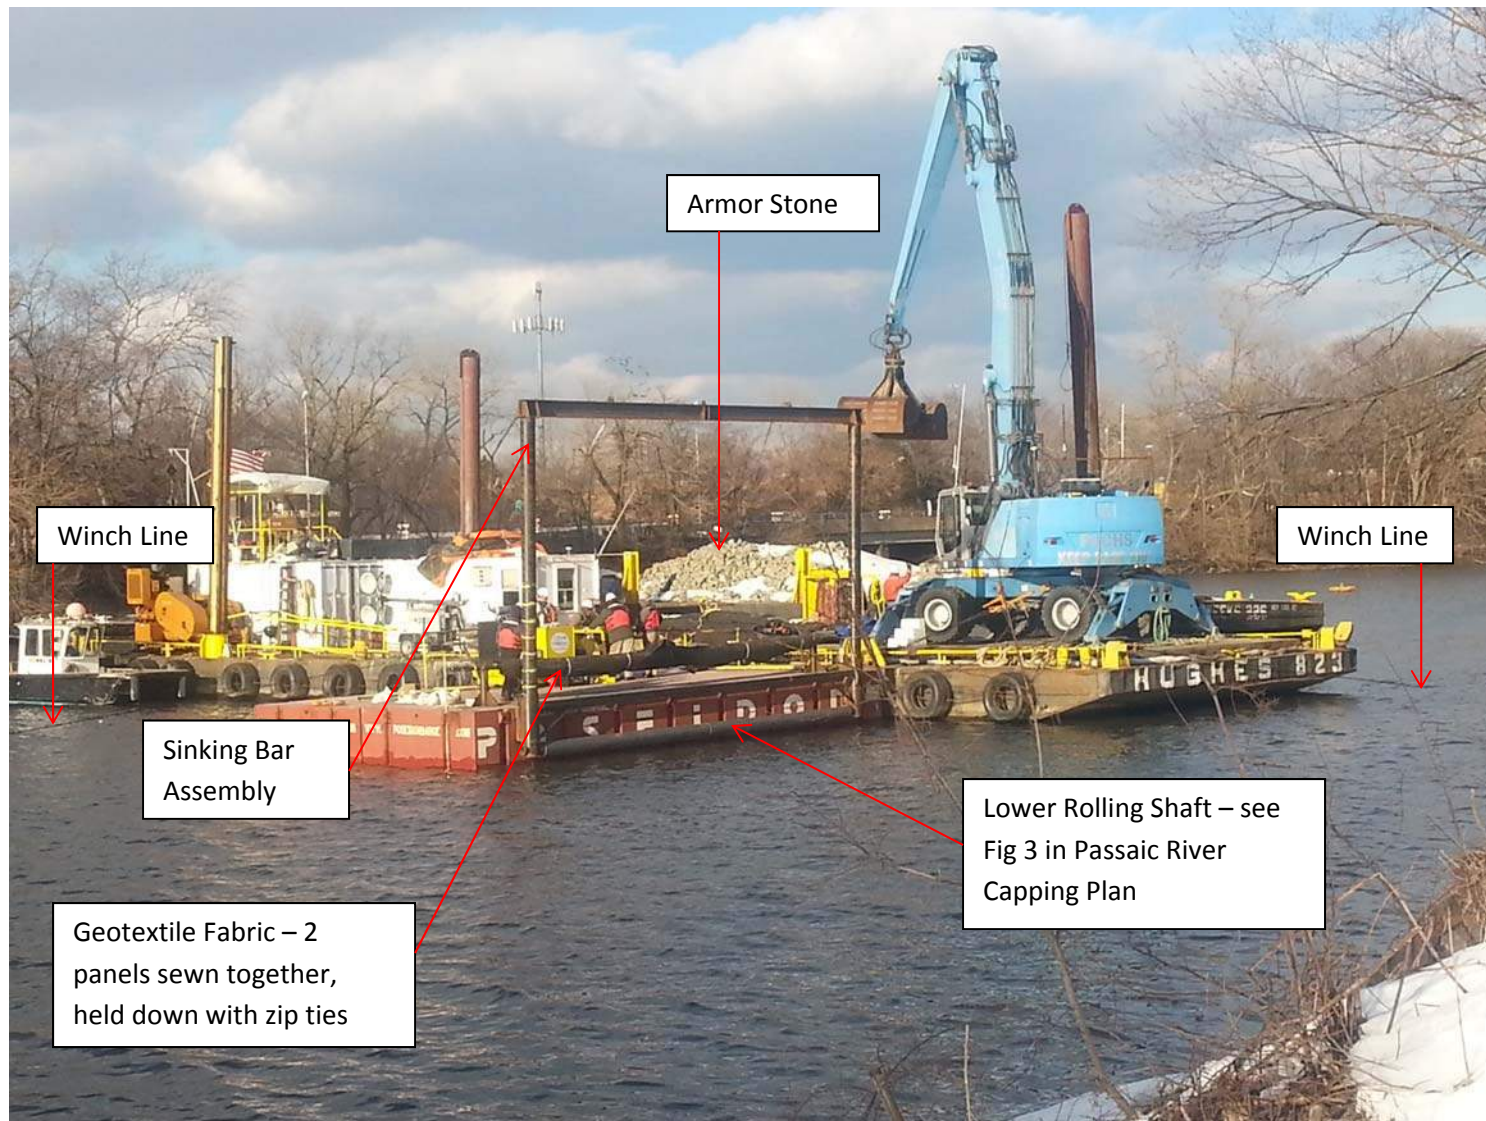
February 25, 2014 1610: New geotextile and armor stone placement assembly.

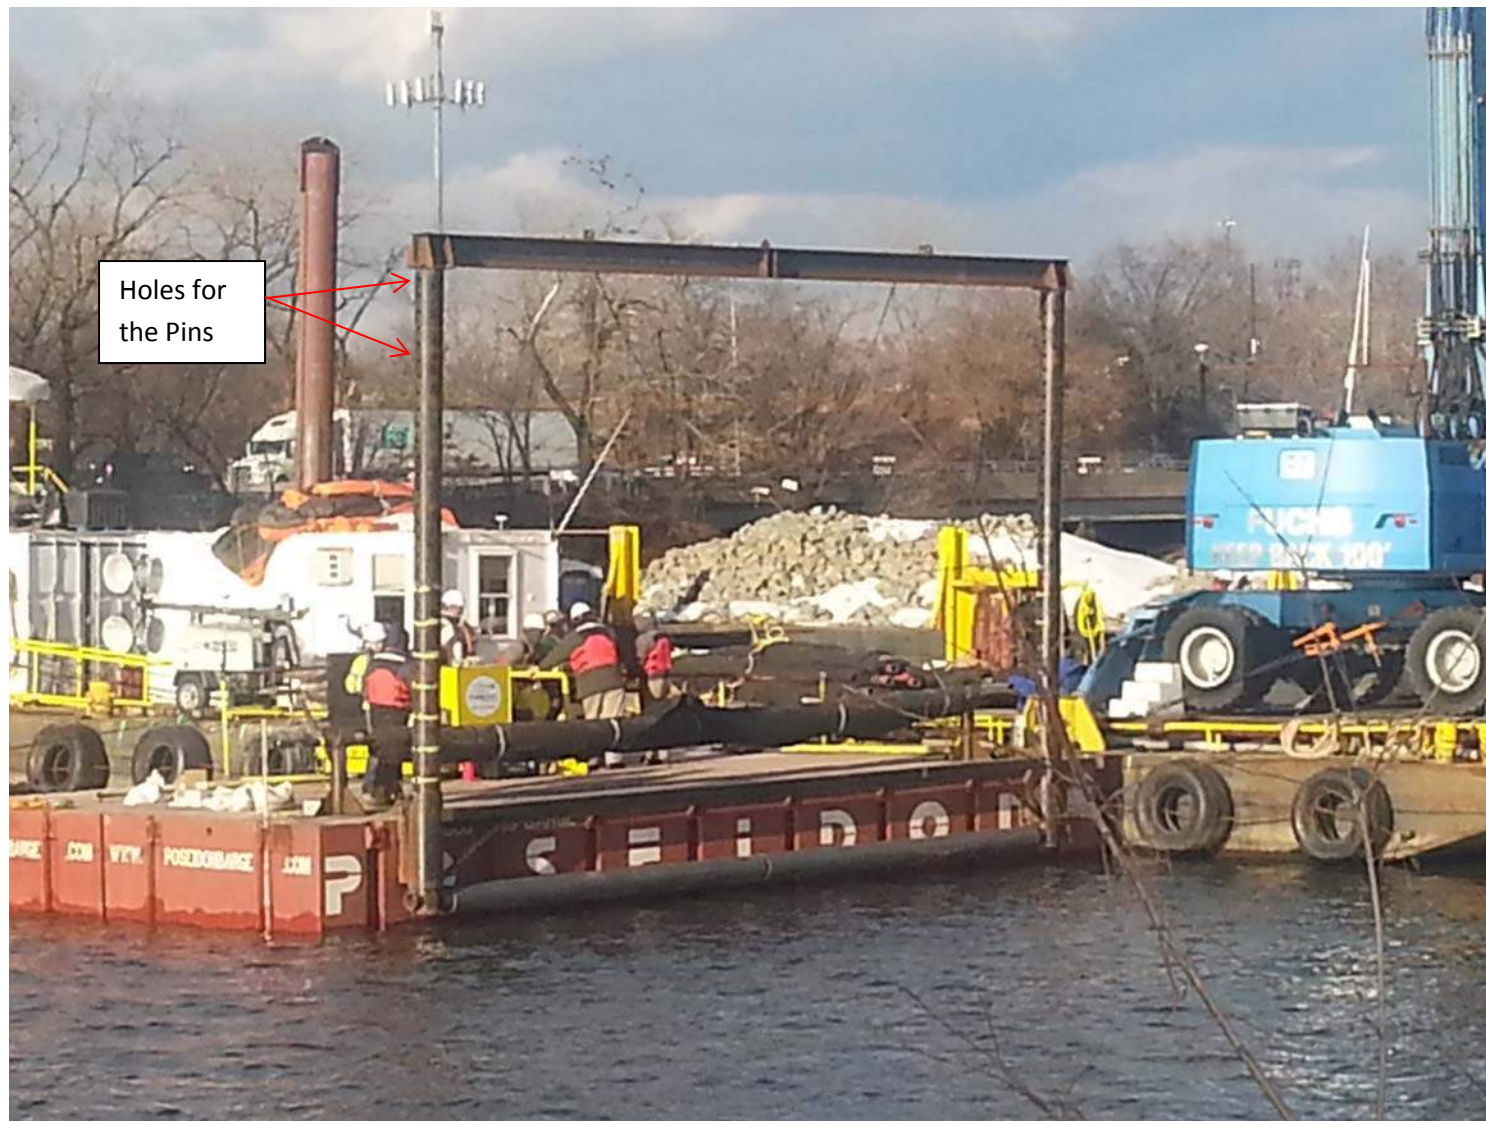
February 25, 2014 1610: Close-up of sinking bar assembly.

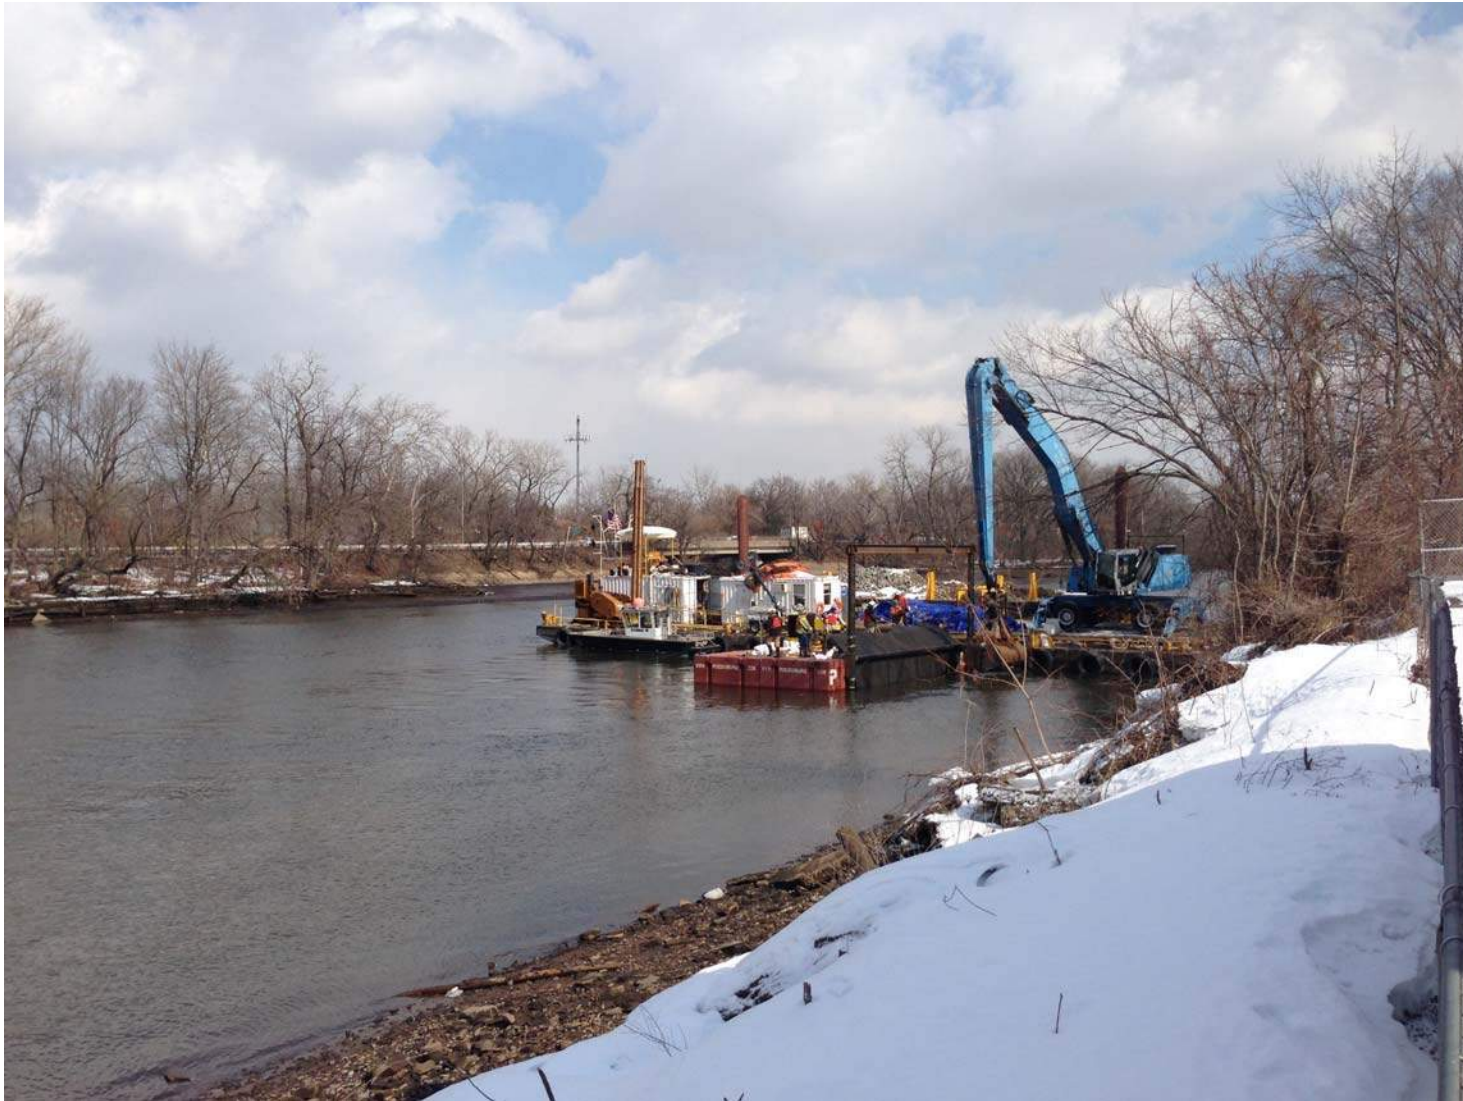
Geotextile Installation

GLDD installed one 20-foot-wide panel of geotextile at the northern edge of the capping area. The installation was performed using the sinking bar assembly. The photograph above shows the crew preparing to release the last few feet of fabric as the Poseidon barge moves away from the shore.

- The installation attempt ultimately failed; as armor stone was being placed, the ropes tethering the panel to the shoreline broke under the weight of the stone. Immediately after, the remaining geotextile fabric on the barge unspooled into the river. The geotextile fabric (a 20' by 60' panel) and armor stone washed out down the slope and into the river channel.

- 1200-1400: GLDD investigated the area where the geotextile placement was unsuccessful.
 - GLDD determined that there was a slope failure in the material beneath the geotextile. They found that the current elevation is lower than the initial pre-dredge elevation, meaning that some or all of the active layer may have been lost into the river channel. It is unclear whether the slope failure occurred today, caused by the armor stone placement, or if it happened before today and GLDD were unknowingly installing geotextile in a low spot. This area was previously acknowledged as a "sleep slope" area. The slope failure is localized, meaning that the areas north and south of this spot have higher, more normal elevations.

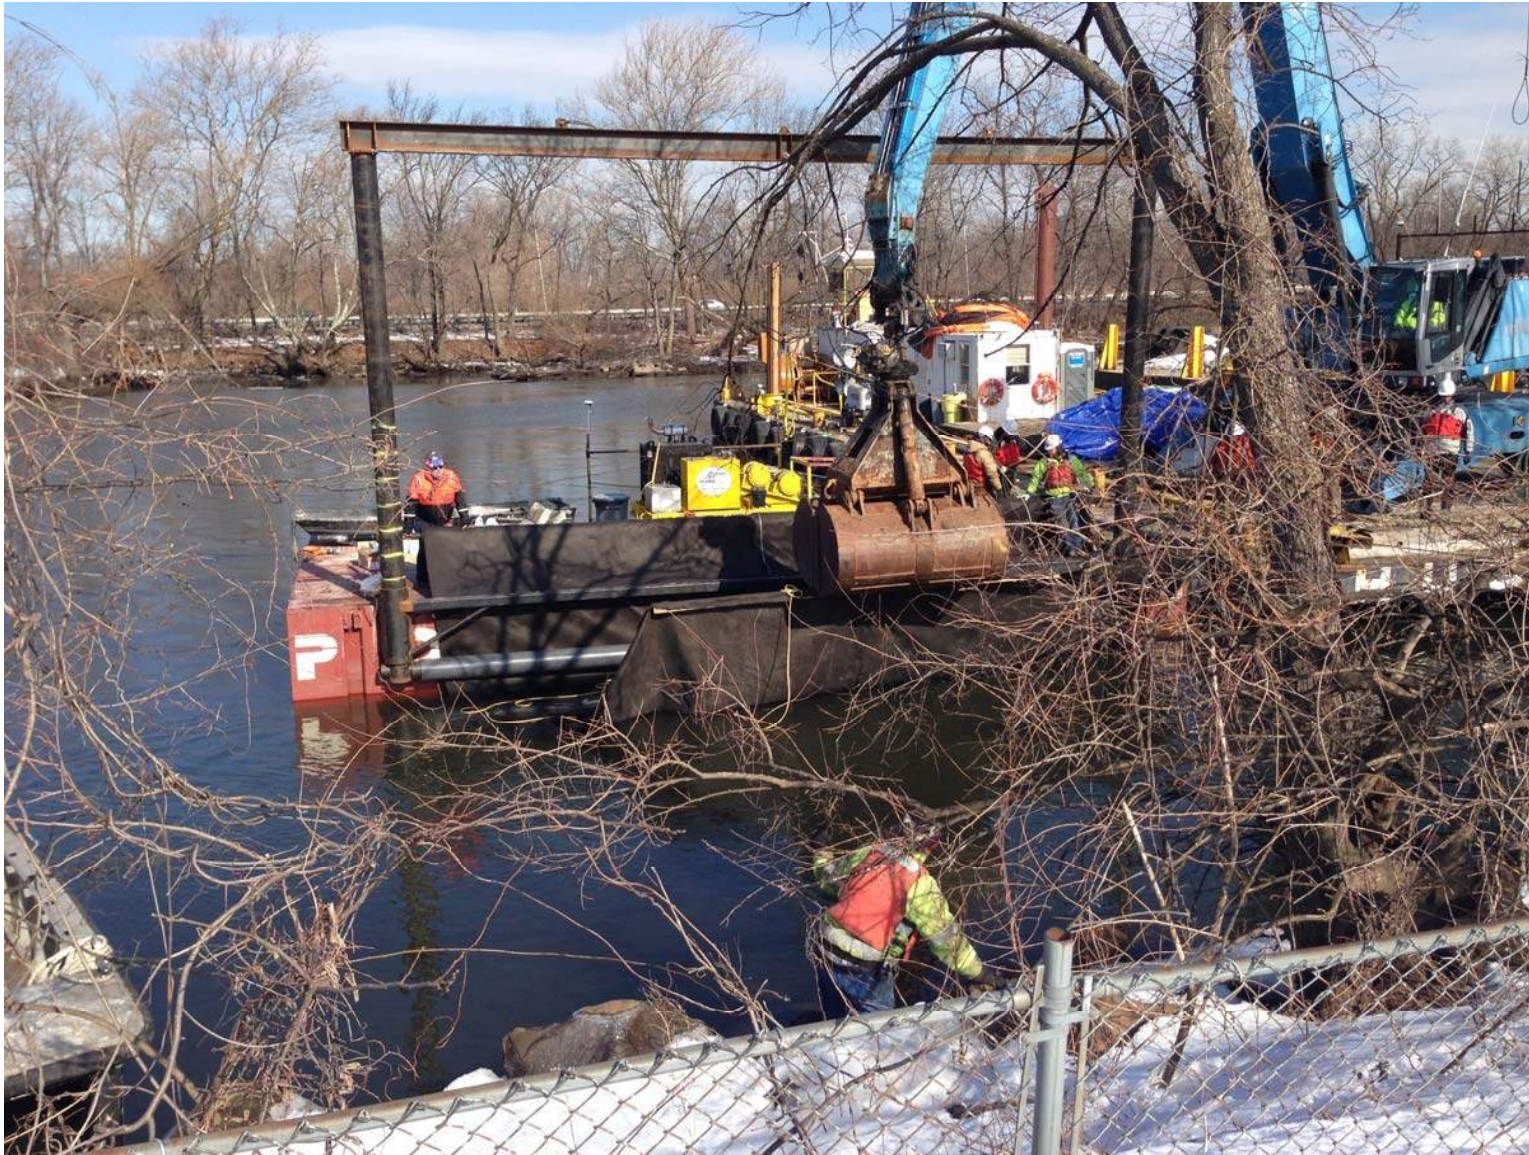
Geotextile Installation

The Fuchs excavator was used to pull the edge of the fabric to the shore, where it was tethered to trees at three locations.

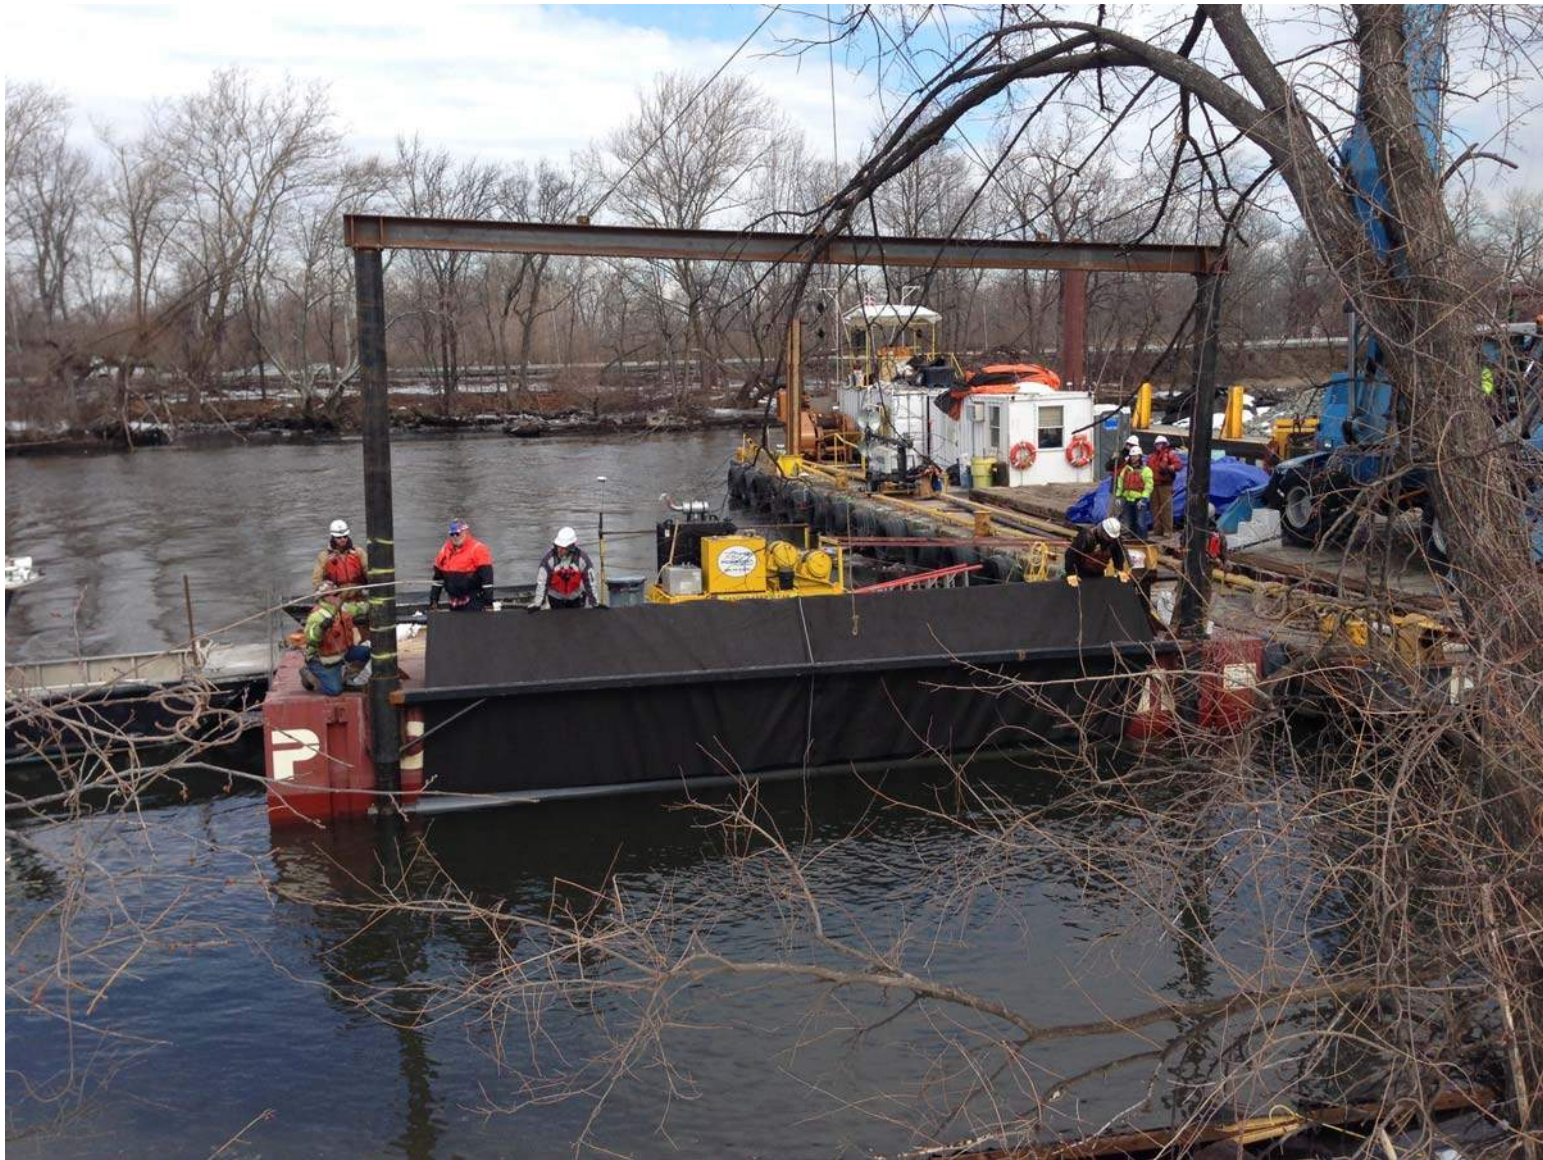
Sinking Bar Assembly Operation

This photograph was taken after the initial armor stone placement and immediately before the lowering of the sinking bar.

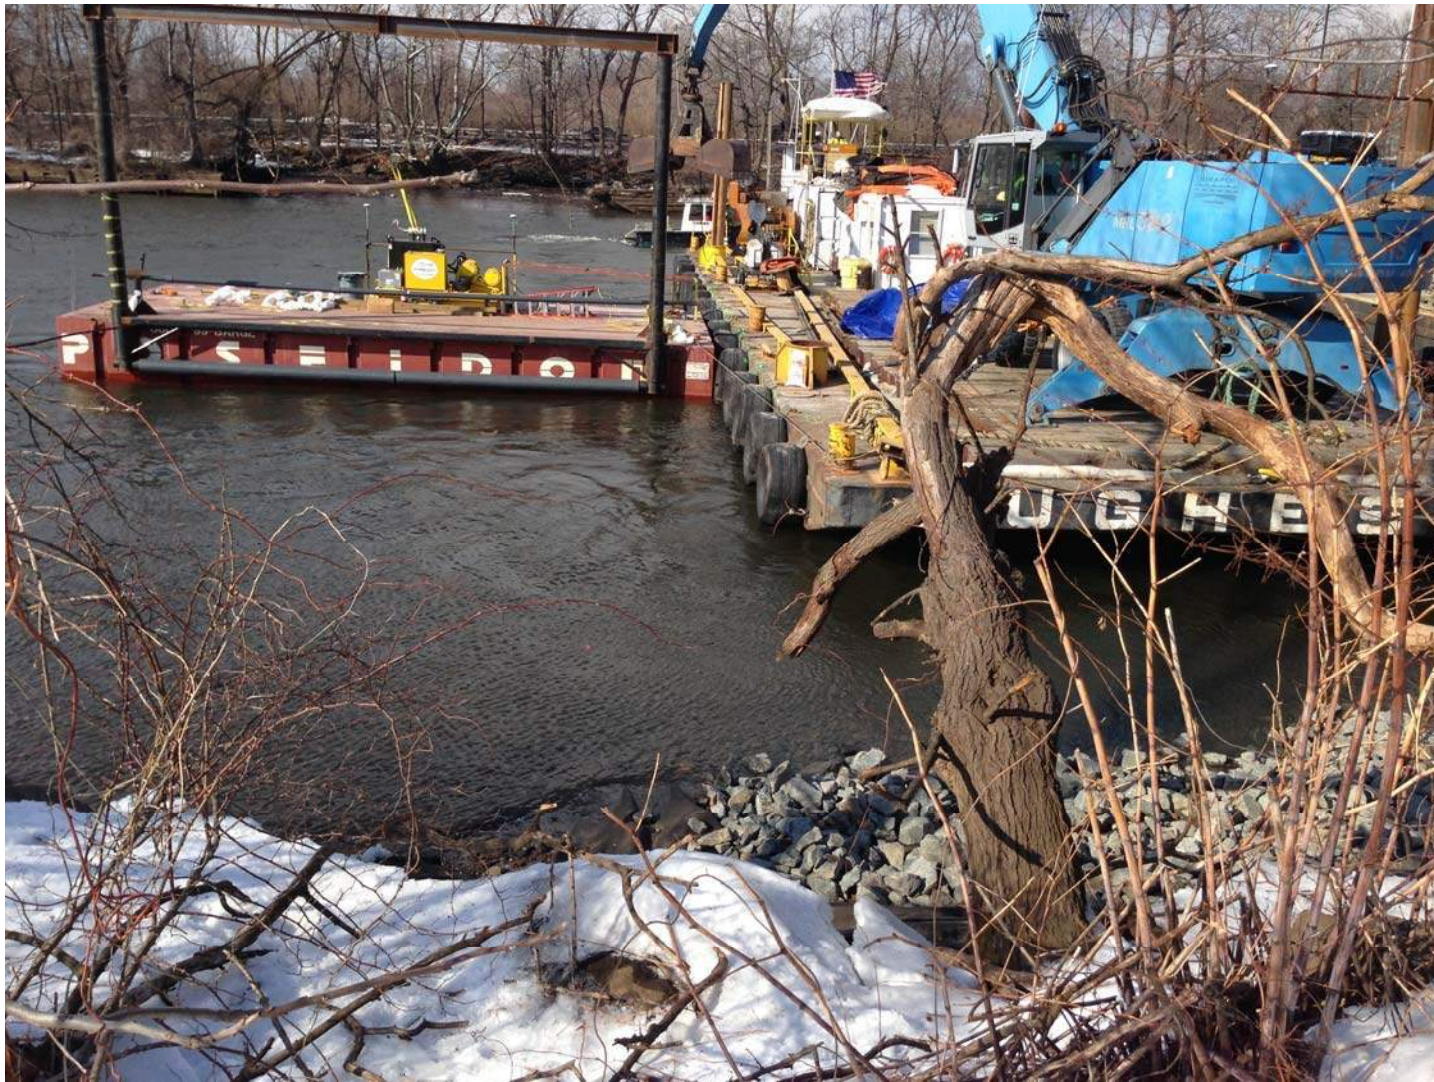
Washout and Yesterday's Progress

At the bottom right is the geotextile and armor stone installed yesterday. The geotextile and armor stone placed today, previously located to the left, washed down the slope and into the river channel.

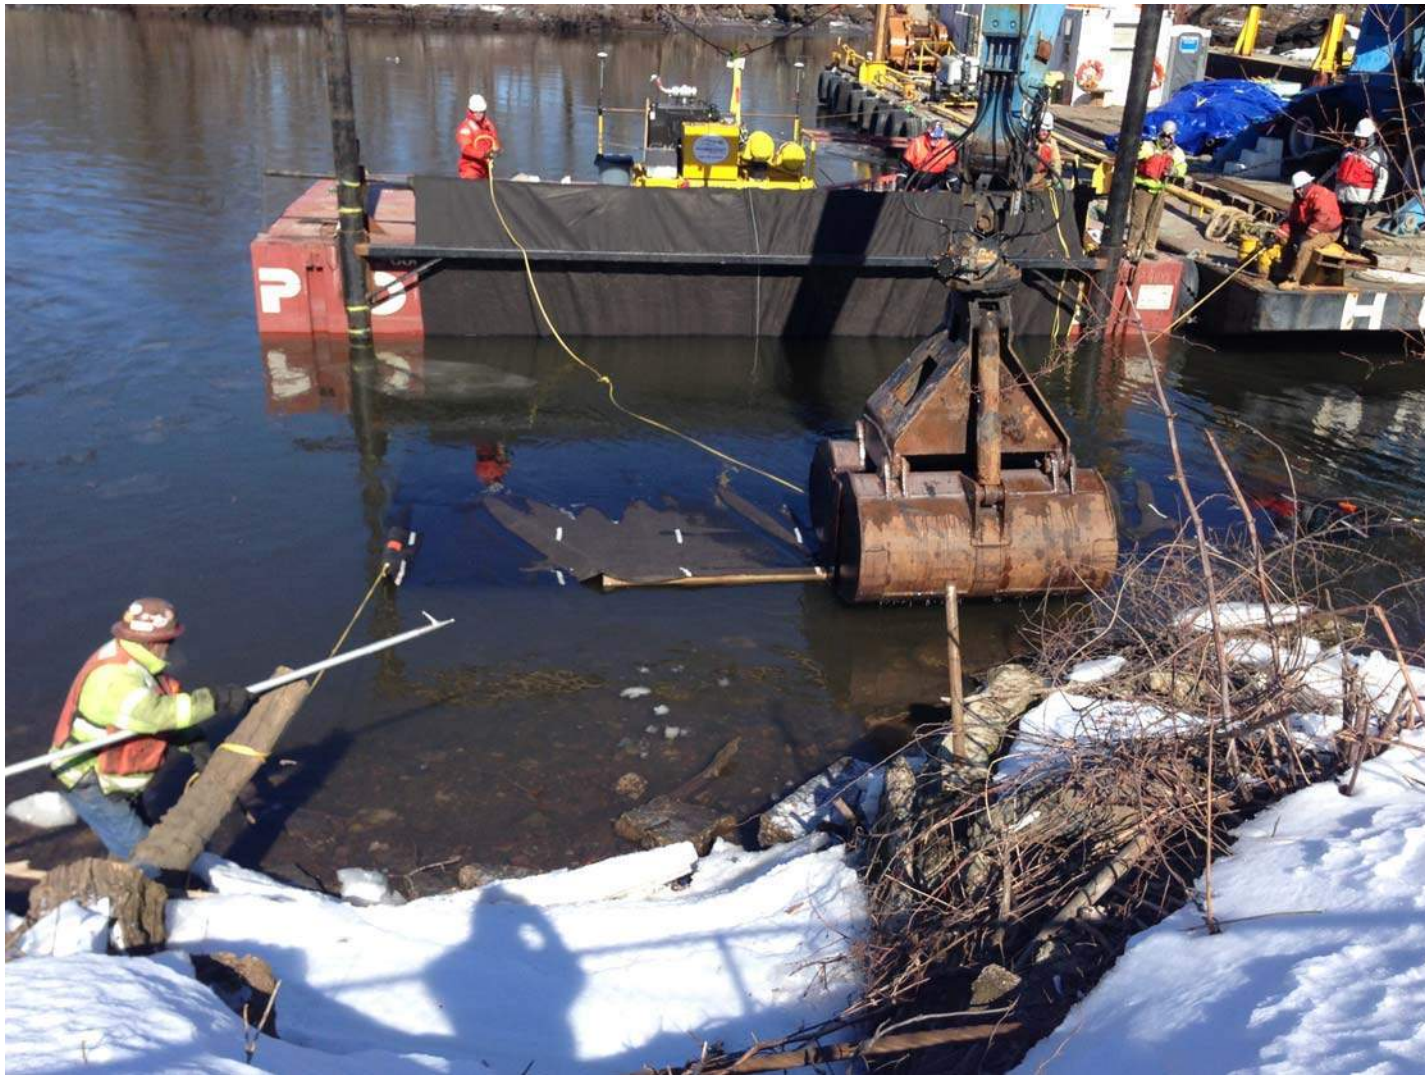
Geotextile Installation

The Fuchs excavator was used to pull the edge of the fabric to the shore, where it was tethered at three locations before the first armor stone was placed.
